A University employee was injured when they fell into an unguarded shaft landing on the floor of the shaft ~12 feet below.

What happened?

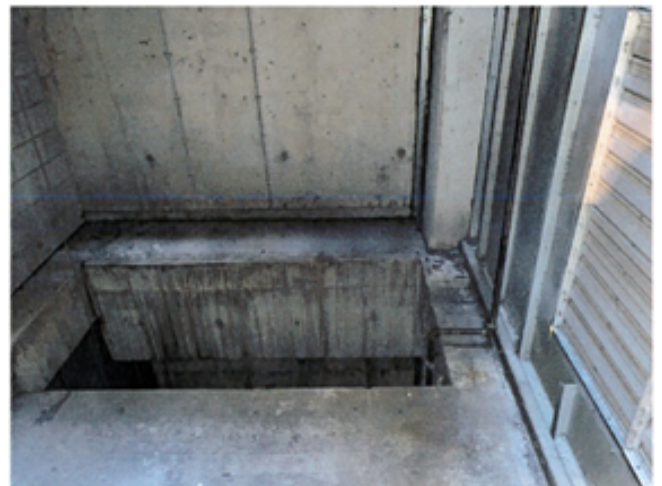
A University employee was injured when they fell through an open shaft in the floor of an air handler and landed on the level below. The interior of the air handler was dimly lit and the employee who entered did not see the fall hazard and stepped backward into the unguarded opening. The employee sustained injuries in the fall but recovered fully and returned to work within a couple of weeks.

Unguarded shaft opening which employee fell into.

- Installation of fall protection systems such as guardrails along unprotected edges that are 4 feet or more above the surface below
- Installation of grates over shaft openings
- Installation or use of adequate lighting in work areas
- Situational awareness - scanning a work area for potential hazards before working in the area
