3. Discovery

Introduction

During the Discovery and Analysis phase of this process the University's current physical campus structure, buildings, infrastructure systems, transportation and transit use, housing needs and academic space assessment were examined.

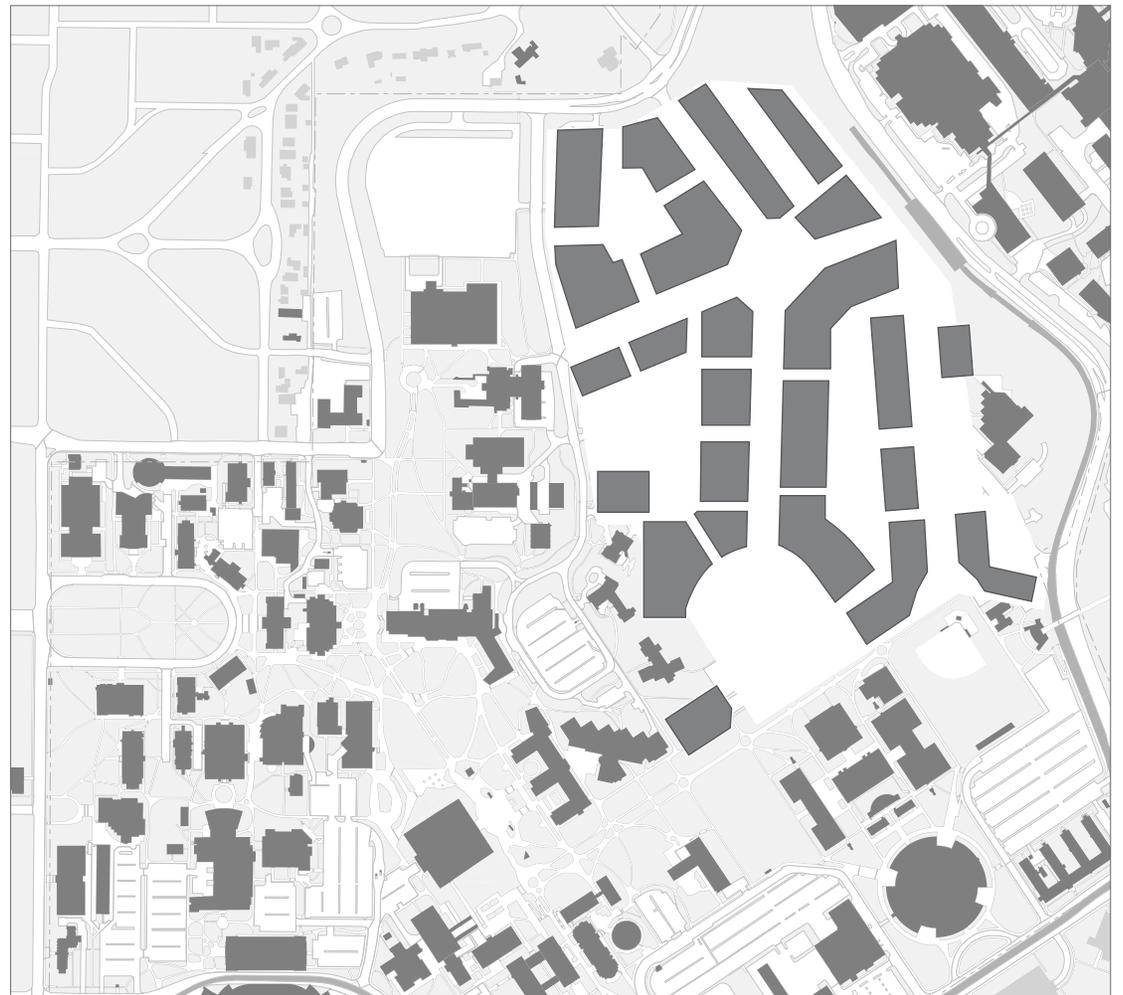
2003 LRDP Supplement *Development implied for the "Land Bank"*

- Rather than a focus on new buildings solely within the "land bank," the Plan proposes a Central Playing Fields zone be established with building development occurring in the northern region in a Interdisciplinary Quad.

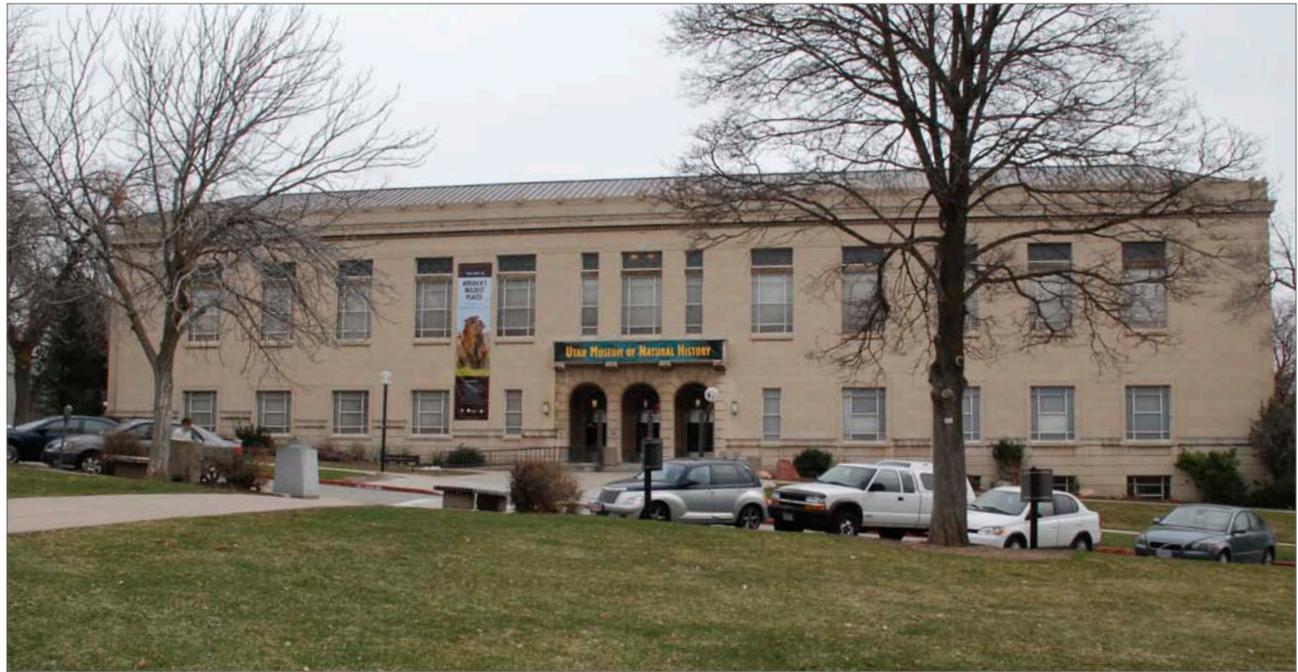
George Thomas Building - Main Entrance at North Facade

The foundation is a system of reinforced concrete continuous and spot footings. The roof framing is made up of steel trusses clear spanning the exhibition space with a concrete roof diaphragm. The roof and floors are supported by a concrete frame with un-reinforced masonry wall which provides the lateral force resisting system. This structure was originally constructed as the main library for the university and served this purpose until being replaced by the Marriott Library in 1968. The 200 ft by 50 ft open exhibition space in the front of the building is approximately 40 ft to 50 ft high. This space creates very high seismic shear forces in the roof diaphragm and also a significant potential for the exterior walls to buckle outward during an earthquake. The suspended floors were designed to support library stack loads and therefore have adequate live load capacity for most building uses.

Seismic Deficiencies: The 1978 remodel did not include seismic upgrade provisions. Due to the un-reinforced masonry and terra cotta exterior, the building is considered very heavy. The roof diaphragm over the large exhibition area is inadequate to transfer the seismic shear forces. The un-reinforced masonry walls do not have adequate capacity to transfer the seismic forces to the foundations. The tall exterior masonry walls at the front of the building most probably do not meet minimum height to thickness ratios and will require strengthening or bracing.

In the short term, prior to funding being available for the appropriate seismic and renovation upgrades, the George Thomas Building could provide “swing” or “surge” space for other building programs that need temporary homes while their current homes are being renovated or rebuilt. Possible candidates for this temporary reuse are the Park Building which is under current renovation and/or The College of Law which has begun a study to determine the long term options for its right-sizing and future growth whether as a renovation to its existing building or the construction of a replacement facility in its current location. The new UMNH building is anticipated to open in 2009 or 2010. This timing may not coincide with neighboring project surge space needs for the effective temporary use of George Thomas. Depending upon the success of the fund raising campaign underway for the College of Fine Arts and its priorities, the Theatre Department may begin their reuse efforts on the heels of the UMNH relocation.

The George Thomas Building’s original steam pipe heating system was converted to a high temp water heating system in 1974. This current 30 year old system will require replacement during the renovation/upgrade.

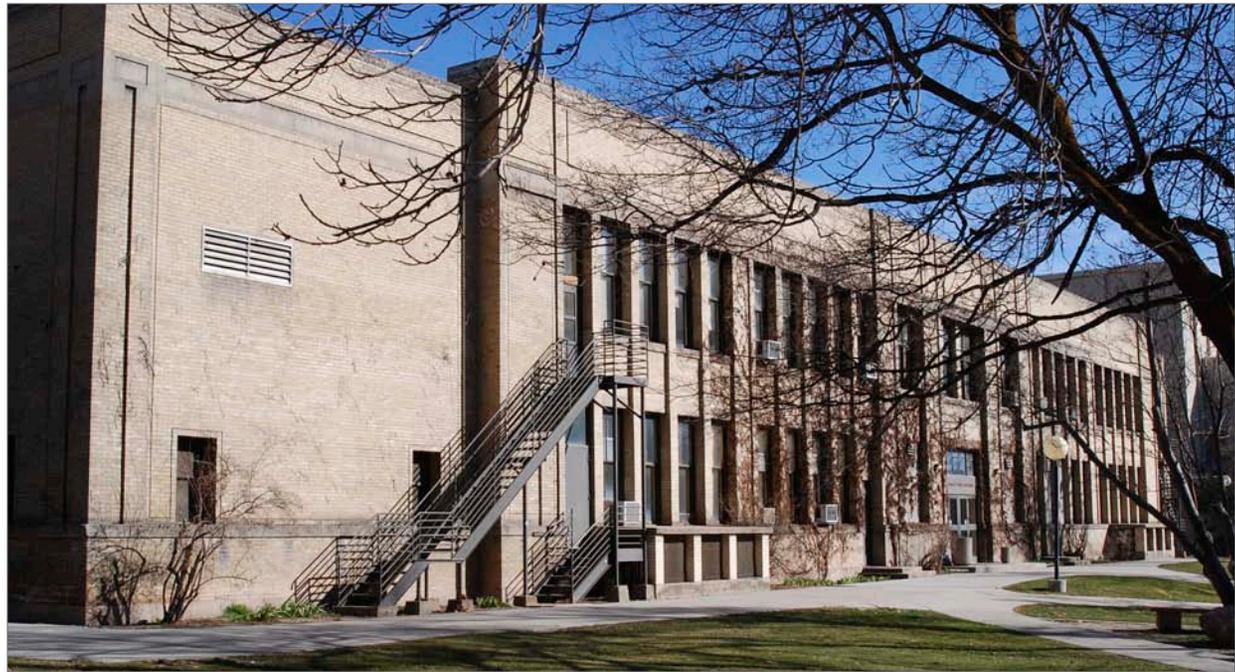
George Thomas Building - Main Entrance at North Facade

The exterior brick of the building is deteriorating and will require re-pointing and a thorough cleaning. The ivy on portions of the building should be removed to lessen the mortar decay. The exterior wood windows are weathered and the sills are in poor condition and should be either restored if a preservation remodel is chosen or replaced if a modern tact is taken for this renovation. The interior of the building for the most part is “tired” and needs at a minimum a repainting. A number of the classrooms still show signs of a leaking roof with stained and crumbling ceiling tiles. The original flooring which is in poor condition, appears to be an asbestos vinyl floor tile which will required appropriate encapsulation or removal.

The HVAC systems in this building include steam, cast-iron radiators, fin-tube units, window air conditioners, rooftop units, a central station split system unit, and ductless split system units. Overall these systems are in poor condition and inadequate to appropriately serve the occupants. A complete replacement system is recommended in order to meet current heating and ventilating codes as well as to provide a satisfactory level of comfort for its occupants. New lighting and electrical distribution system is needed throughout. The electrical system received upgrade with a new switchgear and panel-boards throughout around 2001. The water piping and plumbing fixtures in this building are deteriorated and require replacement. As well the building does not meet current ADA code and will require adherence to Accessibility requirements should this building be renovated and seismically upgraded for continued use.

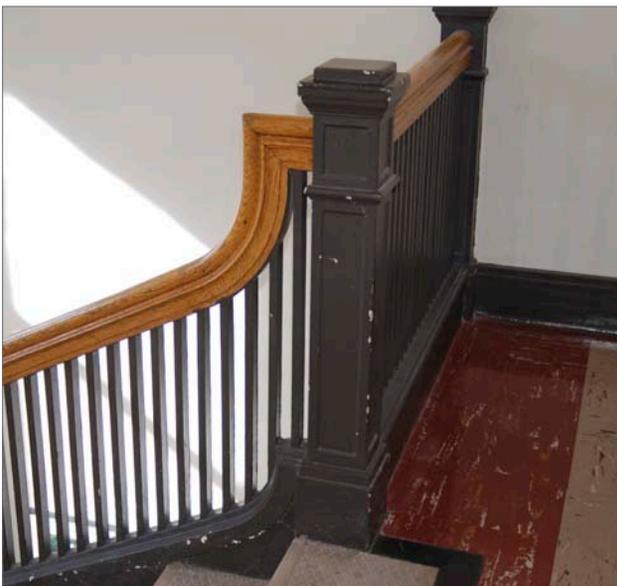
Second floor stair - truncated landing

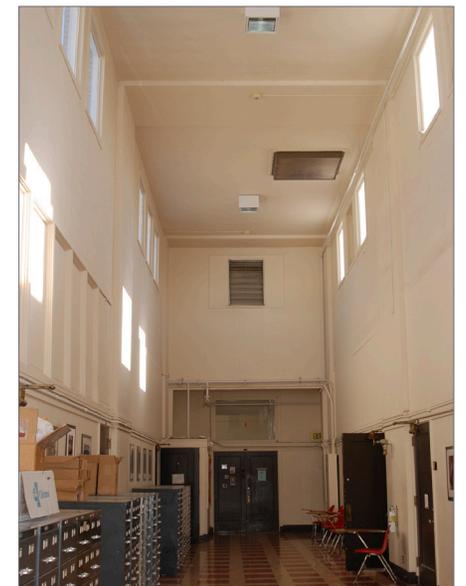
Second floor hall - double height space

Seismic Deficiencies: The exterior frame/walls contain many window openings which create a severe torsional irregularity and afford little resistance to earthquake forces. The structure also contains two-story high interior open spaces that function as the main hallway. This space creates a serious discontinuity in the horizontal diaphragm which could lead to premature failure during an earthquake. The penthouse portion creates a significant vertical irregularity.

Overall the Stewart Building will require an extensive remodel to address the infrastructure deficiencies, code requirements and seismic upgrade necessary to bring this building into compliance and to give it another 50 years of optimal use. It could be coupled with an addition to the west which would help to strength the building and to expand the amount of usable space. The site is prominent and the building, if not given appropriate attention in the next decade could be considered for demolition and replacement. This later strategy would likely be met with local opposition and on behalf of preserving the University's historic legacy should be the last resort.

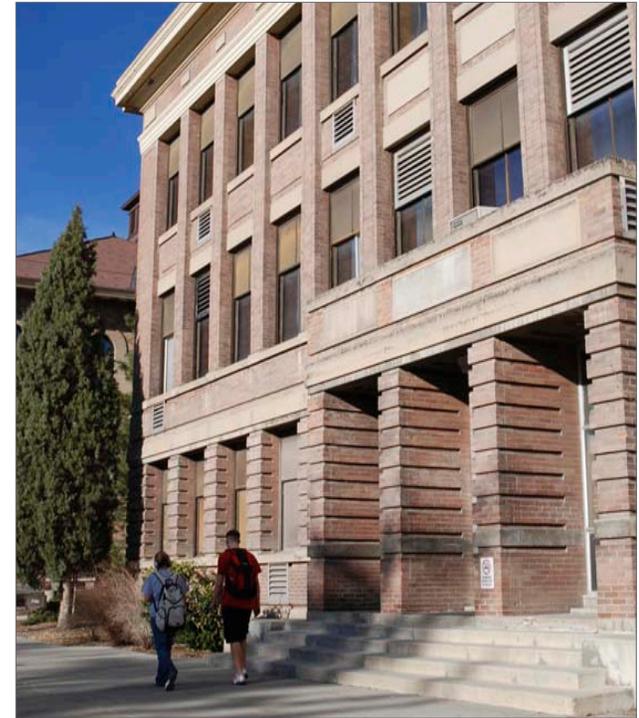
Life Sciences Building - West Entrance

Of more concern in this building than the lack of ADA compliance is the substandard ventilation provision. The exterior brick is in a poorly weathered condition and the mortar is deteriorated. Limestone window lintels are cracked consistently on the eastern side, which may be a result of uneven settling of the building over time. The foundation appears to have been

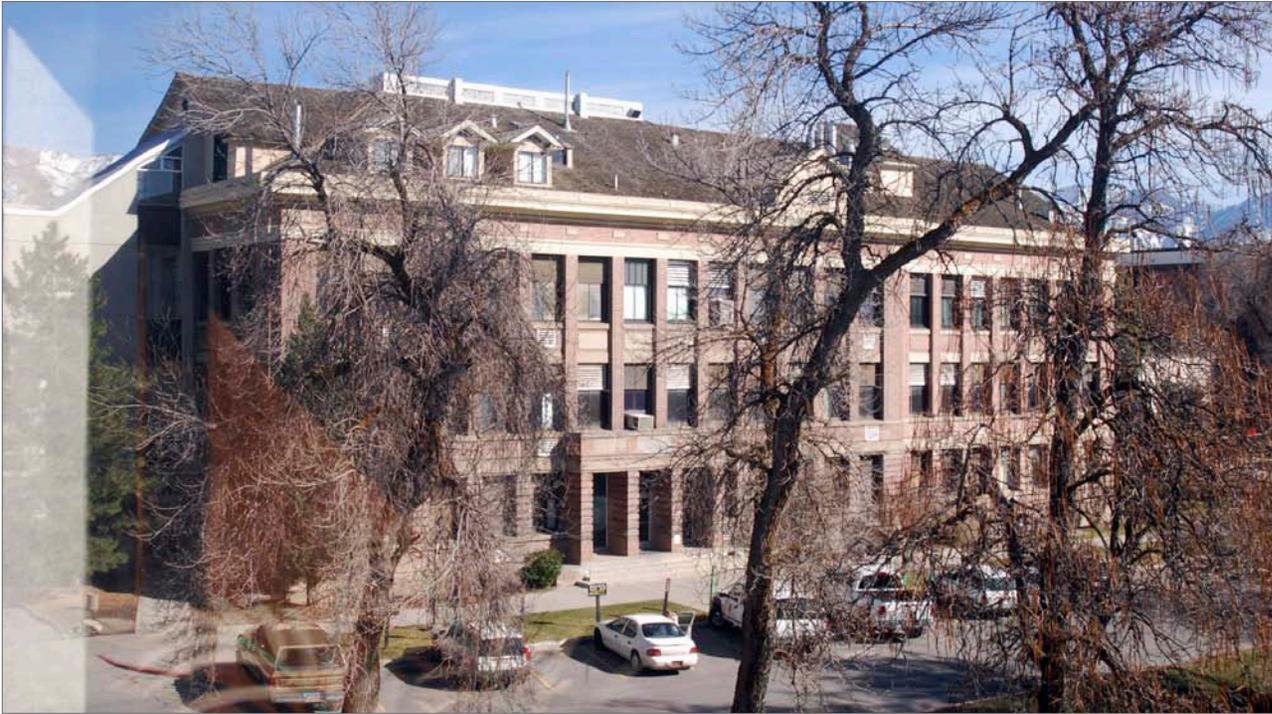
Life Sciences Building - West Facade

Seismic Deficiencies: The chimney and cornices are considered to be a falling hazard. The lateral stability offered by the stairwells may not be adequate to prevent major structural damage. The un-reinforced masonry walls are not adequate to transfer the lateral seismic forces to the foundations.

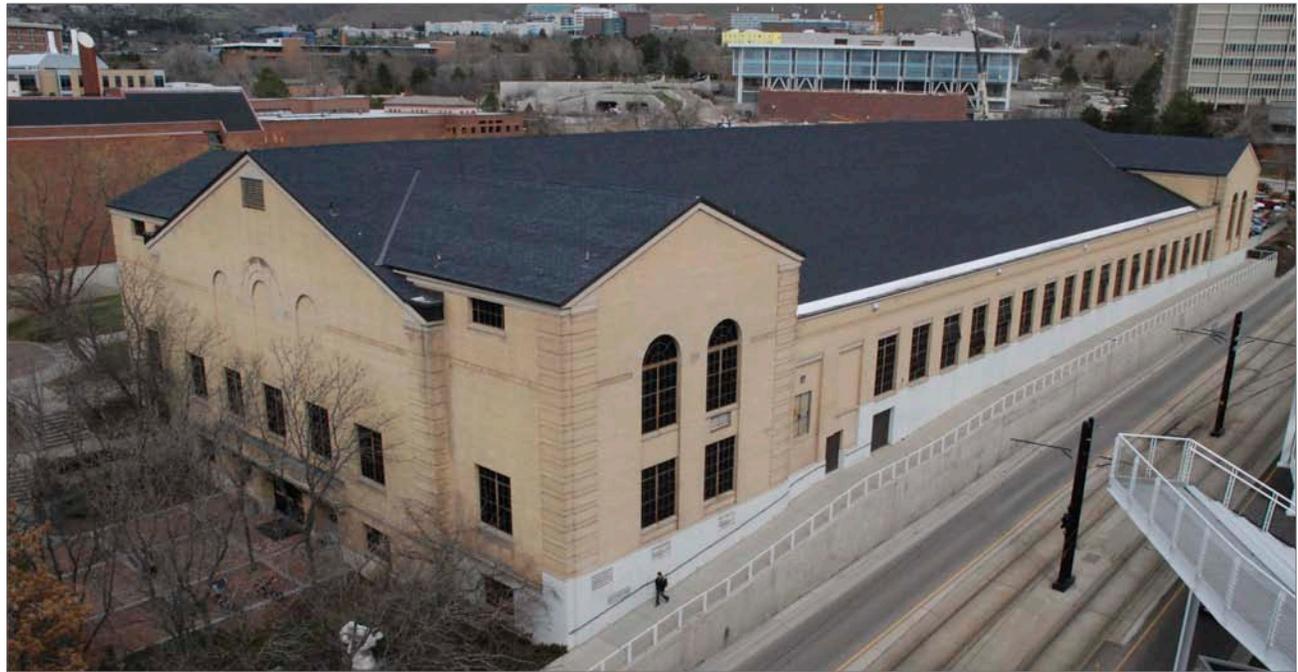
The Einar Neilson Fieldhouse was built in 1939 to expand the indoor athletic facilities on campus. At the time the existing gym built in 1906 could no longer accommodate the expanding athletic programs. Today the Einar Neilson Fieldhouse is widely used by students, faculty and staff as the primary recreation facility on campus. The athletics program on campus moved into the Huntsman Arena, the shared Athletic and College of Health facilities on HPER Mall and other facilities along Guardsman Way. The Fieldhouse has four levels following a remodeling in 1976, which created upper level racquetball courts and a dance studio. It also reworked the lower floor offices and locker rooms. The main area of this building is on the second floor, which is at grade on the eastern side of the building. This second floor contains indoor tennis courts for the university faculty, staff and students. This same portion of the building also has an elevated indoor running track. The field house has a rectangular footprint with roof gables on each of the four corners of the building. This building totals 72,250 gross square feet.

The 1970s HVAC system is past its useful life and provides inadequate ventilation in many portions of the building. The large open fieldhouse volume is problematic in the warmer months and the occupants have resorted to large floor fans placed at exit doors left open at both sides of the building to create cross ventilation and some relief from the heat. The interior is dated and worn, and would benefit from a remodel upgrade. The exterior brick requires cleaning, repair and repointing. The windows are single pane lattices which should be replaced with structurally sound construction that is suitable for their height in regards to seismic safety, yet similar in lattice proportion in

The foundation is a system of reinforced concrete continuous and spot footings. The roof is composed of steel trusses-arches supporting wide flange purlins.

Seismic Deficiencies: The steel trussed-arches require additional analysis to verify their ability to support the required roof gravity loads (snow) and also to verify the lateral wind and seismic load capacity. The steel rod bracing in the east-west direction was probably used for temporary erection stability until the un-reinforced masonry infill walls were installed. The exterior walls have many large window openings providing natural daylight to the gymnasium and will not provide adequate resistance to lateral wind and seismic forces in either direction.

Although a number of programs have examined the Fieldhouse for possible re-use, the most natural candidate would be the Department of Athletics. Having given up this building in the past with their move to the southern portion of campus, the Athletics Department has requested a new opportunity to re-use this building for their expanding women's programs especially. Women's Volleyball courts with spectator seating would be ideal for them. Returning spectator sports to this building will warrant increased occupancy evaluation. It is the recommendation of the CMP team that the long term use of the Einar Neilson Fieldhouse be thoughtfully approached and that the building receive the restoration and seismic upgrade that is needed rather than considering the facility for immediate re-use after the Student Life Center is built and the Fieldhouse is vacated.

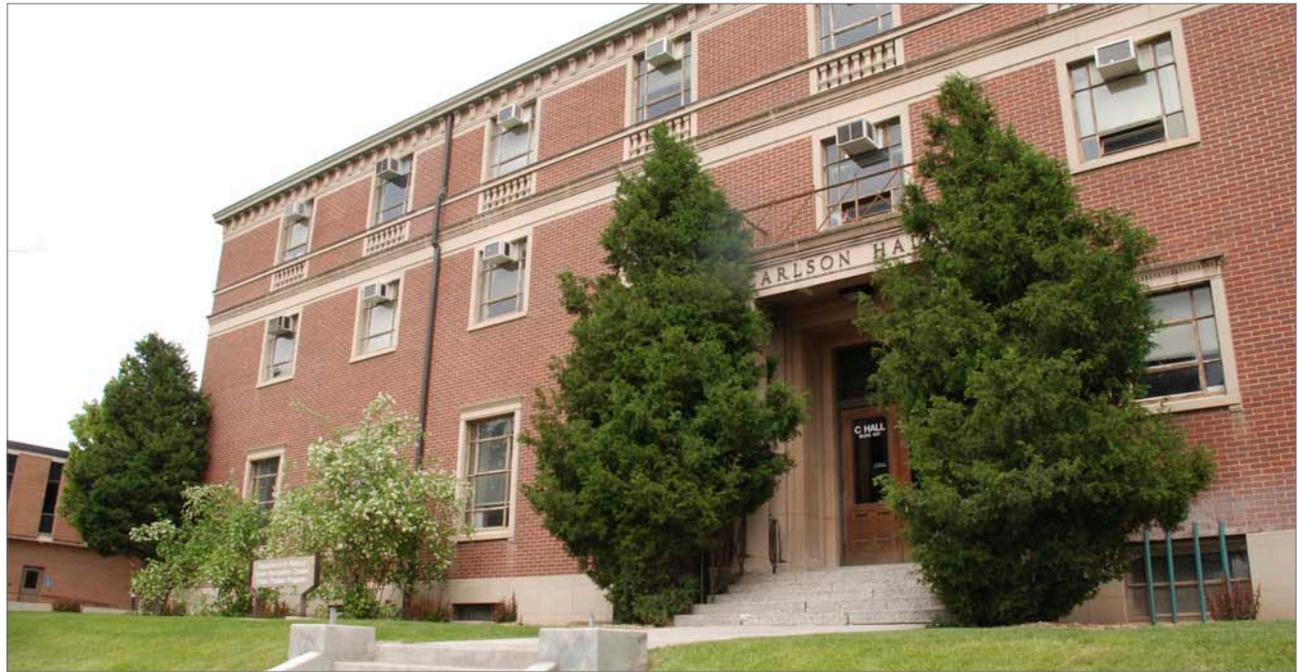
Carlson Hall - Main Entrance on University Street

The foundation is a system of reinforced concrete continuous and spot footings. The floors are constructed of a system of concrete slab and one and two way concrete pan joists. The roof is composed of concrete one way pan joists bearing on steel trusses and concrete beams. Interior columns are made up of reinforced concrete. Exterior columns are concrete wall pilasters. Walls are constructed of unreinforced masonry. The lateral force resisting system consists of unreinforced masonry walls.

Seismic Deficiencies: The building configuration includes an irregular plan layout with vertical discontinuities. The un-reinforced masonry walls have inadequate capacity to resist the required lateral seismic forces. The horizontal diaphragms are not connected to the shear walls adequately to transfer the seismic shear forces.

venues on campus would be ideal. To re-use Carlson for this purpose would require toilet/bathroom upgrades and additions considering the previous residential accommodations were dormitory style with congregate toilet/showering facilities by floor. This amount of renovation would likely trigger an ADA upgrade and fire-life safety code compliance including a fire sprinkler system.

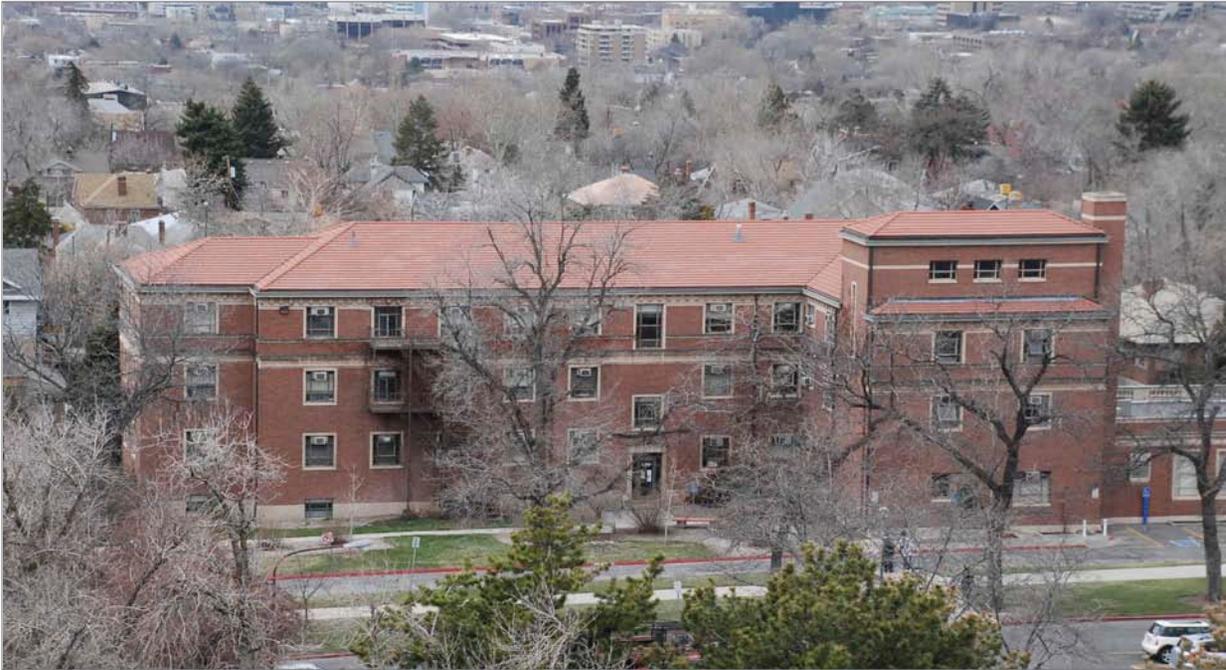
Carlson Hall · Rear Entrance at East Facade

The fate of Carlson Hall is quite a dilemma. As many of the un-reinforced masonry buildings on campus, it too would require seismic upgrade in order to provide adequate long-term earthquake preparedness. This will come at a substantial cost compared to the value of the building. It has historic value given its age, but will take considerable amount of remodel to provide ADA accessibility and code compliance. The College of Law in its adjacency is considering the possible reuse for fac-ulty offices. Overall the site that Carlson Hall occupies at the corner of University Street and South Campus Drive would warrant a more substantial campus build-ing. Re-building the College of Law in this location would be an appropriate candidate.

Another possible re-use for this building would be as a visiting scholar or performing artist residence. The College of Fine Arts currently rents space in local hotels to house their visiting performing arts faculty and staff which come to the University for several months at a time for seasonal stage productions and teaching engagements. The proximity to the performing arts

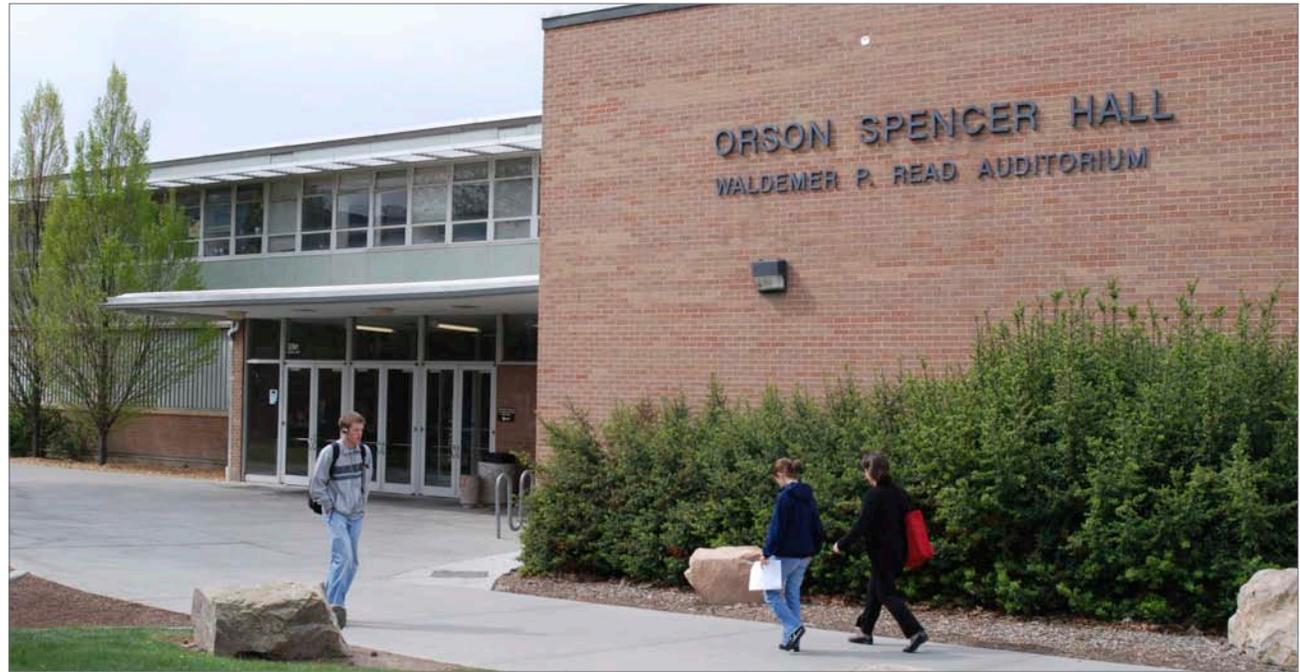
Orson Spencer Hall can fondly be described as the “work horse” classroom building on campus. It has served as the concentration of undergraduate classroom space on the main campus and in its 50 years of existence has had minimal upgrades due in part to its constant use.

In the initial investigation and interview process related to this building, its upgrade and renovation needs were thought to be possible, accomplished in phases one wing at a time. The ISIS review did not provide a structural review. The recommendations from Reaveley Engineering as stated in the structural seismic section that follows identifies the need for a moment frame reinforcement. This type of structural renovation will require that the building be vacated as the interim stages of upgrade to the moment connections will cause unequal loading to the overall structural continuity of the building.

Renovation of OSH will be too costly and will require vacating the building to do the work. The CMP recommends that Orson Spencer Hall should be replaced. Replacement classrooms will need to be built prior to its demolition. The preliminary findings of the current "Disaster Resistant University" study being conducted also support this conclusion.

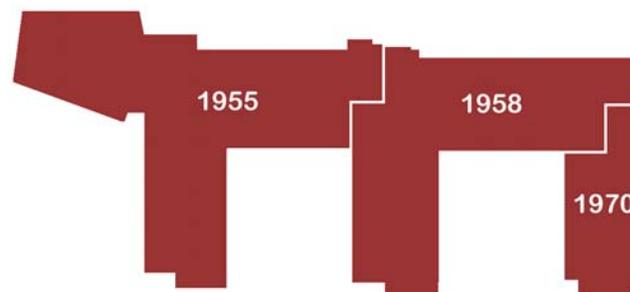
Orson Spencer Hall Inter-connected Phases

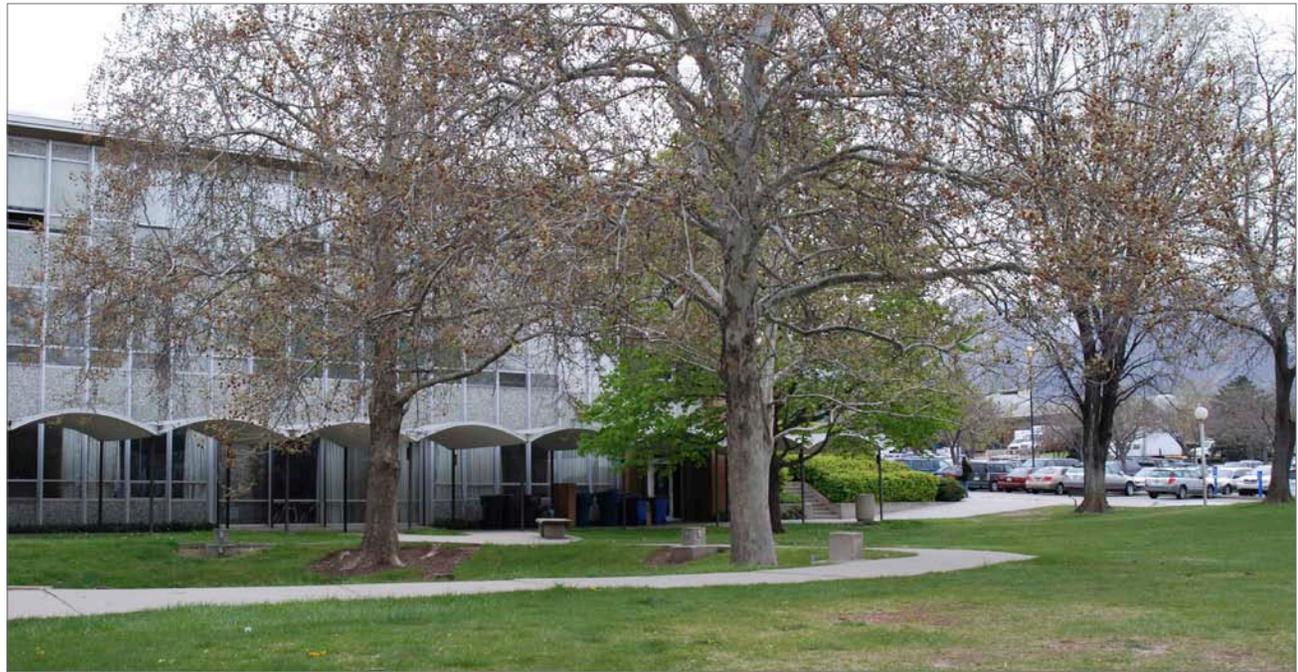
Milton Bennion Hall was built in 1959 as a three story building housing the College of Education. It appears that the building's interior has been reshaped over time to maximize the usable program space. These remodels of the building, to gain more office space, have resulted in code minimum corridor mazes which lack aesthetic appeal. Other areas of the building have been sequestered to provide overflow relief resulting in lounge furniture and chairs for waiting occupying many of the hallways and open stairwell areas which compromise circulation movement in the public corridors. The interior of the building is in fair condition with only spot locations which show need for repair such as corridor ceiling tile damage due to pipe leakage. Although many classrooms have been fitted out with AV equipment the building would require additional systems remodeling for technology ready classrooms to bring the building up to campus standards equivalent to the recently built Health Science & Education Building and Warnock Building. Overall the infrastructure systems for this building are outdated and require upgrading.

Seismic Deficiencies: The shear walls which run north and south in the west wing increase the lateral forces in the building because of added forces due to the effects of extreme torsion. The existing concrete shear walls do not meet current building code requirements to resist the current code specified lateral forces. The "T" shape of the building creates adverse effects at the corners where the west wing joins the main building. The floor and roof diaphragms are not connected together where Phase I meets Phase II. Also, the floor and roof diaphragms do not have adequate anchorage to be able to transfer the current code lateral forces to the existing shear walls. The interior partitions are not laterally braced.

As stated in the Building Assessment introductory page; for a final structural score of less than 2 the CMP team recommends that a detailed seismic evaluation be conducted. Milton Bennion's score of 1.2 would suggest that the extent and cost of seismically upgrading may outweigh its useful return on investment. Over the course of the CMP study the team met with the team preparing the "Disaster Resistant University" (DRU) study. Both teams consider Milton Bennion Hall as a replacement candidate; citing code deficiencies, outdated HVAC, and poor seismic condition as reasons to replace rather than renovate this building.

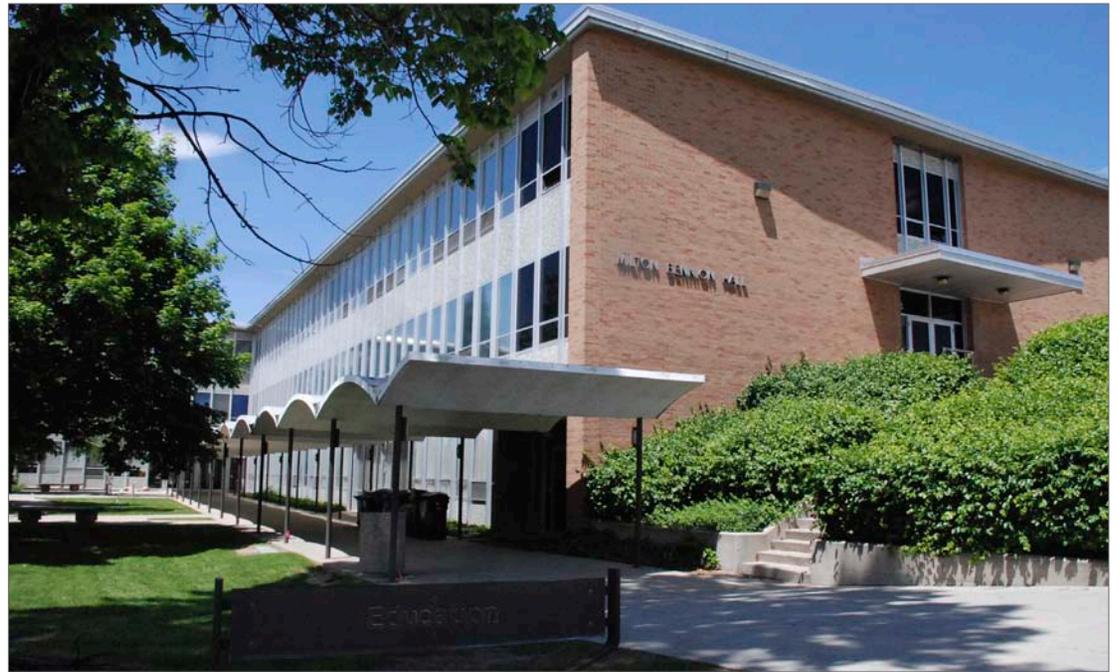
Milton Bennion Hall - Southern entrance view

RVS Information: This building received a final structural score of 1.2 and given a seismic rating of very poor.

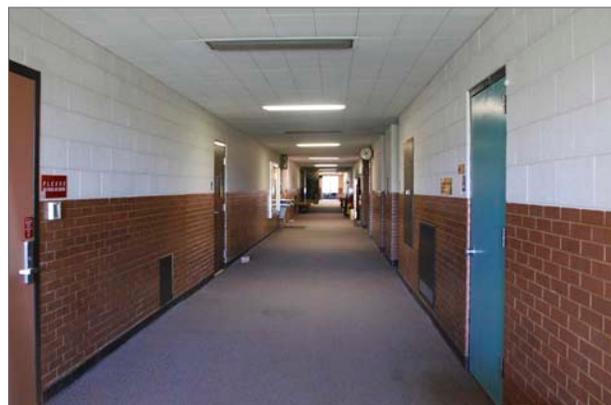
Typical block wall infill at corridors on all levels

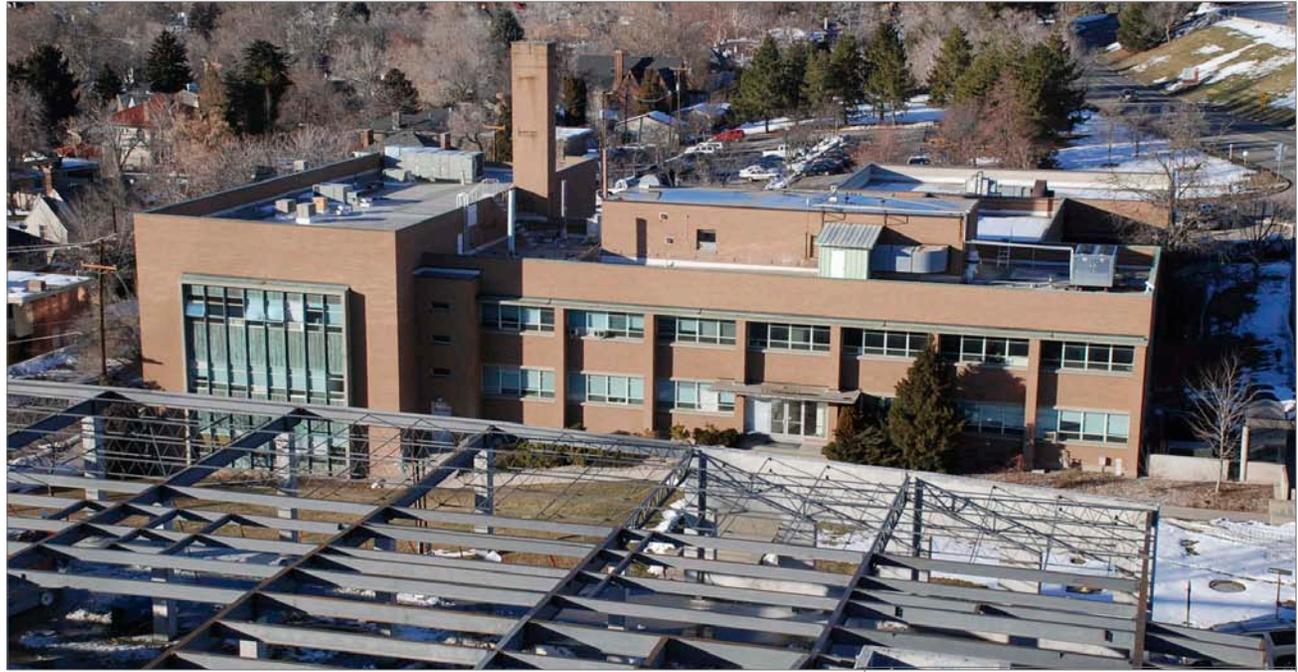
View of Kennecott from roof of Warnock - Sutton construction in foreground

The Kennecott Building is used by the College of Engineering for faculty offices and program spaces. It was remodeled in 2001. As per the recent renovation study conducted for the University, the building still needs extensive work including interior carpet and ceiling tile replacement, bathroom remodeling, ADA upgrades, fire life safety upgrades and stair code compliance. The brick facade is in good condition.

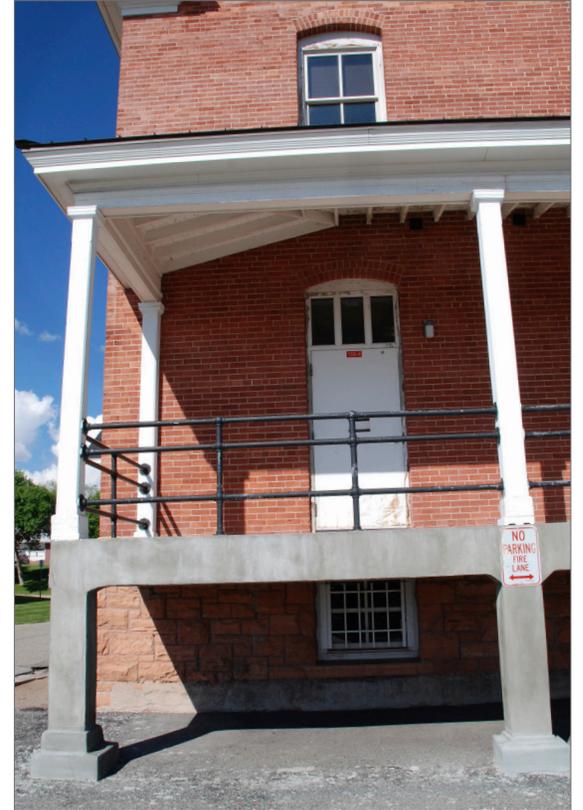
Rear building views of porches

Layouts for buildings 102-108 are similar. Originally the buildings had front porches constructed of wood. The brick has been filled in on the second floor door openings and converted to window sashes. Building 104 is the only building which still has its original porches. Rear porches and exterior stairs remain for the majority of the buildings. The buildings are “U” shaped plans with a narrow depth to provide through-ventilation.

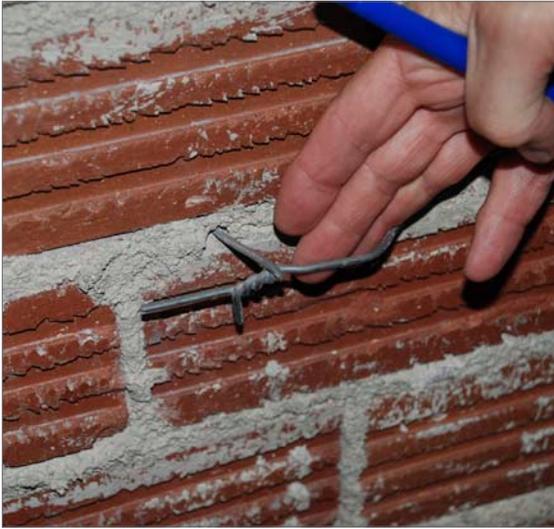
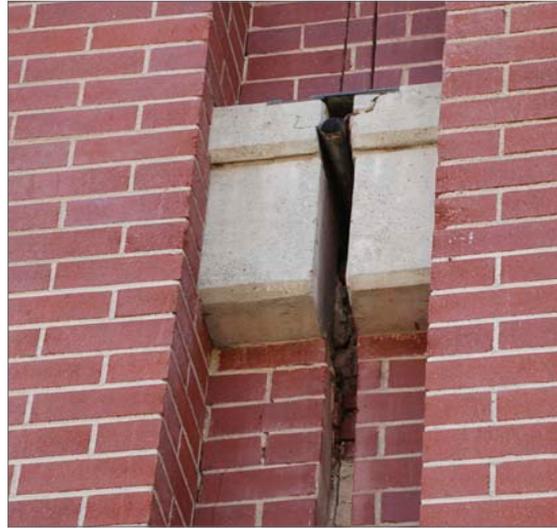
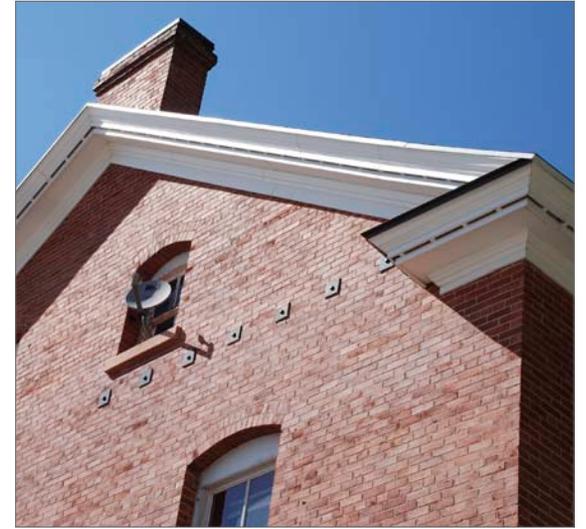
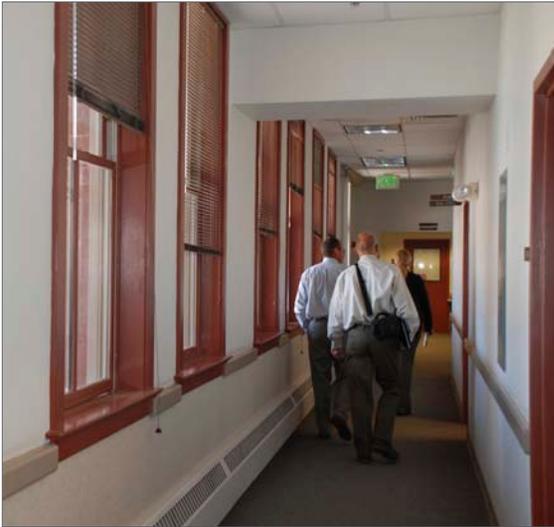
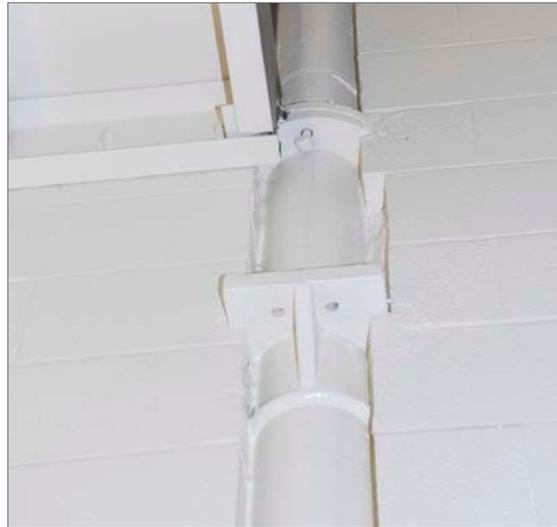
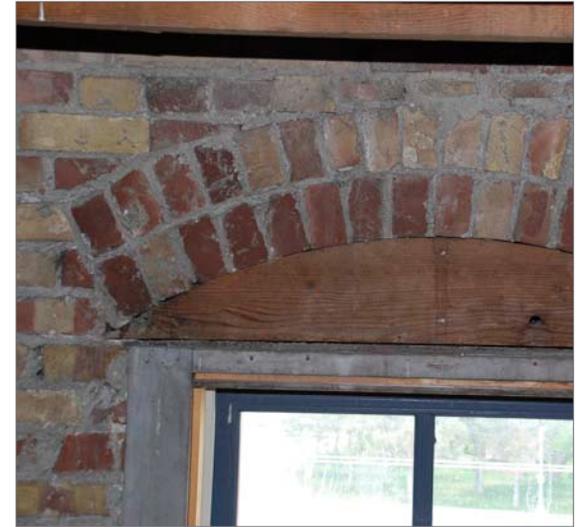
Buildings 102 through 108 were all built between 1904 and 1910 with similar construction and configuration except building 104 which is significantly smaller than the other buildings and is not constructed in the typical “U” shape. The foundations are sandstone block with both continuous and spot footings. The exterior and interior bearing walls consist of unreinforced masonry. The roofs and floors are framed with solid wood joists, beams, and columns. Lateral force resisting systems consist of partial diaphragms with little or no connection to unreinforced masonry shear walls.

Exterior and interior views and details

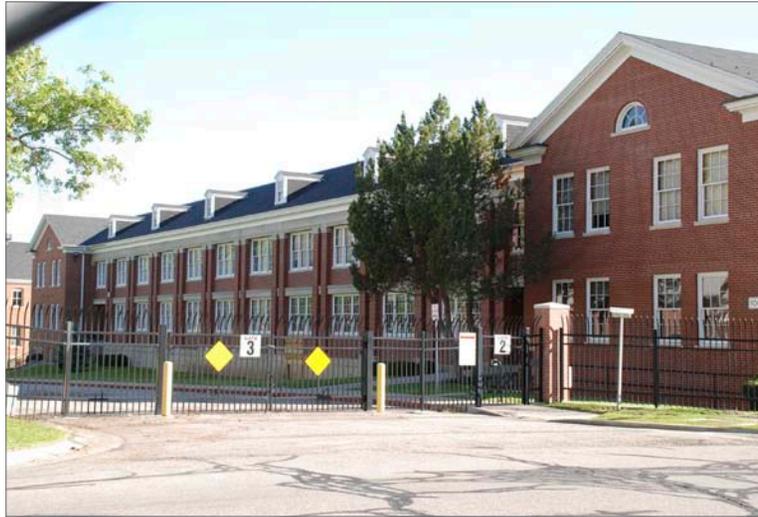
Building 100

Building Description: The structure was built in 1939 making it one of the most recent structures at Fort Douglas. The foundation walls consist of reinforced concrete. The building is a two story reinforced concrete frame structure. Columns are 17” by 17” reinforced concrete. Column gridlines are approximately 16’ by 18’-6”. The roof is framed with wood joists at 16 in O.C. and wood sheathing. Walls at gables are 12” thick with clay tiles on the interior and brick on the exterior.

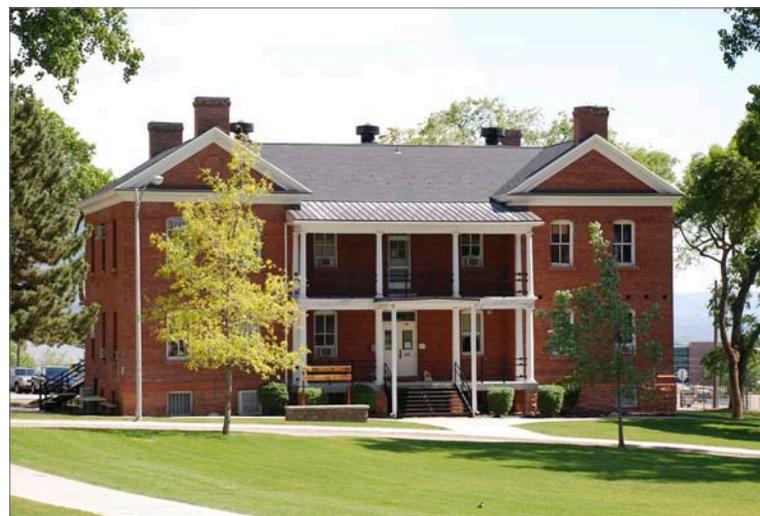
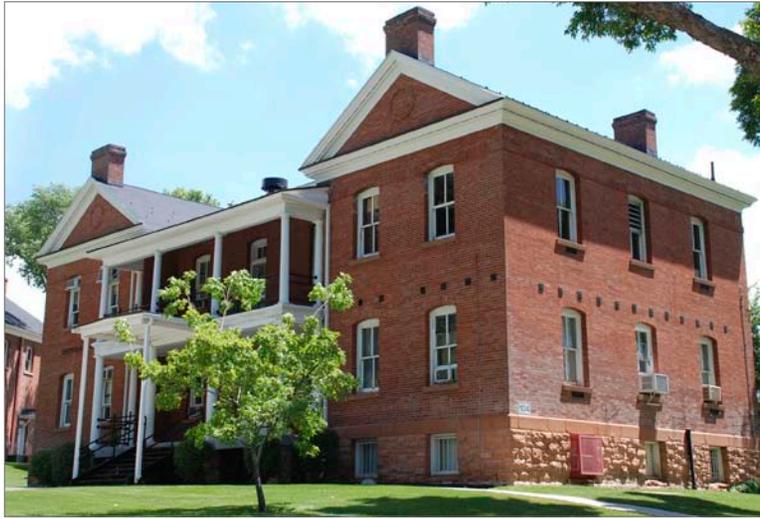
Bldg. #1 04

Leopold A. Yost Hall - Bldg. # 104 North west view

The exterior walls are 15” thick unreinforced brick masonry, the interior walls appear to be 6” wood stud walls with lath and plaster on each face. The lintels over the doorways in some of the interior bearing walls appear to be framed with wood members.

The floor has diagonal sheathing that has been overlaid with another layer of sheathing at some later date. The floor is framed with 2” by 12” joists at 16” O.C. The joists at the wings span 22’ east to west and are pocketed into the masonry walls. The joists in the main portion of the building span north and south between the exterior and interior masonry walls. The greatest span is approximately 11’. The joists have wire and plaster attached to the bottom. The plaster is painted with lead paint that is considered a hazardous material and thus has special requirements for the method of removal.

Building Description: The building is listed in the National Register of Historic Places on the national and state historic registers. The front of the building faces north and is located on Soldiers Circle. This building is significantly smaller than the other buildings on Soldiers Circle and is not constructed in the typical “U” configuration.

The building consists of two floors and a basement. The story heights are approximately 12'-9" tall. The roof is sloped and has a pitch of 8" rise per 12" run. This equates to an attic height of 8' at the peak. The building has a main body with two small wings at each end. The main body is 30'-4" by 30'-0". The wings are 22'-11" by 39'-0".
